3 Anyridge implants for mandibular rehabilitation of a patient with a fractured implant

A.Dinparvar*, M.Motamedi*

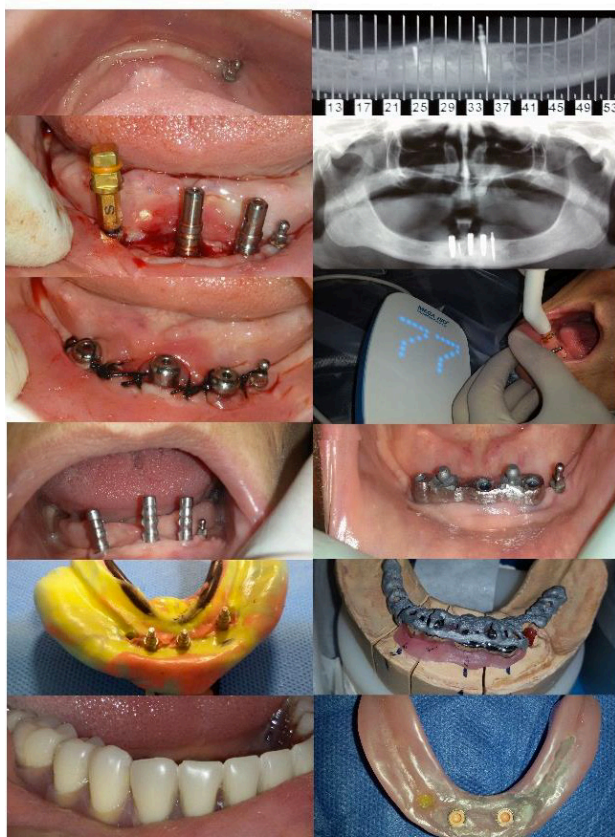
The case is a 61 years old female presented with a fractured mandibular implant-retained overdenture. The failed prosthesis was retained by two mini-implants loaded separately by o-rings. The right mini-implant body was fractured after three years of use. Implant removal could lead to severe mandibular bone loss, so two 4.5*10mm AnyRidge implants were placed between the existing mini-implants, and the third 4.5*10mm AnyRidge implant was placed on the right side first premolar region.

After 10 weeks, the ISQ value for all three implants was recorded over 70 by the Mega ISQ device. Impression was made then and a bar was designed to connect the new implants. A basemetal mesh was also designed to embed in the acrylics and reinforce the new overdenture. Based on the patient's demand, the acceptable upper complete denture remained unchanged and the lower prosthesis was delivered.
